Manhole Inspection Summary

Manhole # S25GG1005MH

Insp Date: **1/23/07 2:17 PM**

Location Address: **1201 40TH ST**

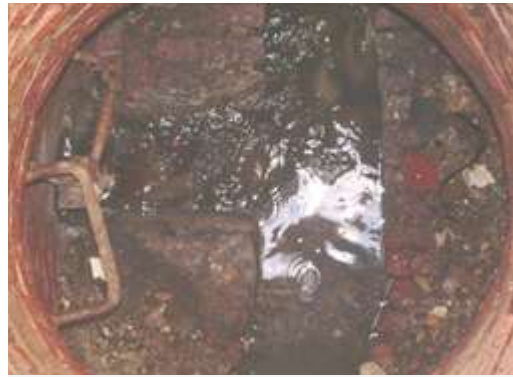
Top View

Corroded steps. Evidence of surcharge - Bench debris. Channel debris.

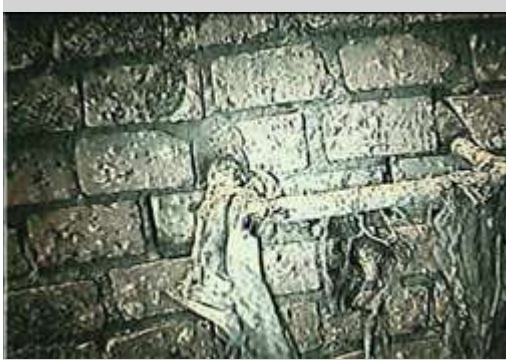
Defect

Evidence of surcharge.

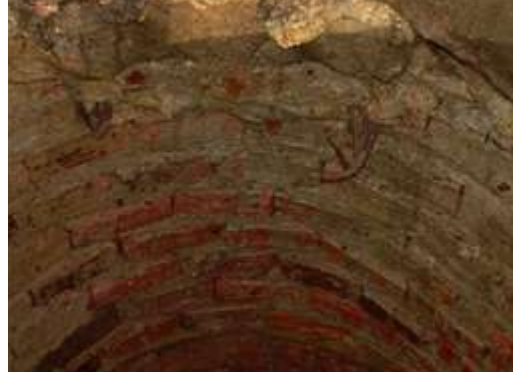
Defect

Frame leaks. Adjustment infiltration. Corroded and missing steps.

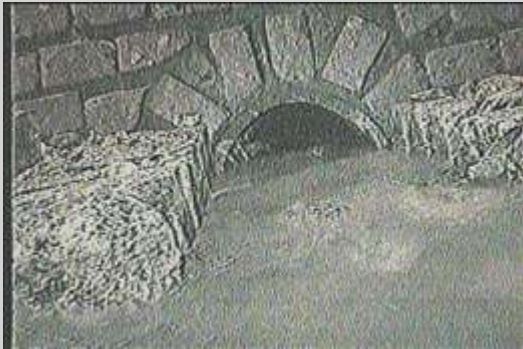
10 in. Circular Gravity Sewer Pipe Out @ 12 O'Clock

Barrel deterioration, loose brick and infiltration.
